A RALLYE

N° 120

CORRESPONDING TO MODIFICATION N° 123

SUBJECT : Location of the rudder control on the rudder pedals.
Replacement of the rod nut by a guide nut.

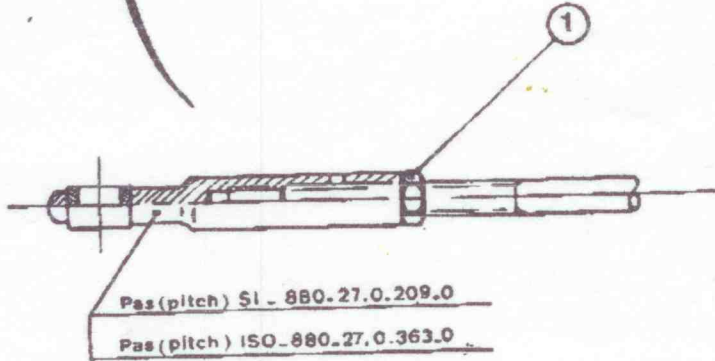
AVANT
(BEFORE)

On the other hand, at the time of overhaul or maintenance operations, some unusual manoeuvres can create abnormal buckling stresses on the rods (for example : the manoeuvre which would consist in pulling one rudder pedal while the other is maintained unmoved). This buckling may, in borderline cases, cause the failure of the rod in its threaded area, behind the eye bolt which ensures the attachment with the rudder pedal. A few similar incidents having occur, we have provided a safety device which consists in replacing the nut, item 1, by a guide nut, item 2. (see figure on page 2/3). This guide nut which has an important length and is bored at its ends, forms a bushing which is engaged both on the eye bolt tail (previously undercut) and on the plain length of the rod. This prevents any bending in this area.

Remove the old eye bolt n° 880.27.0.209.0 and the nut item 1.

Remove the old eye bolt n° 880-27.0.363.0 and the nut item 1.
