A RALLYE

N° 120

CORRESPONDING TO MODIFICATION N° 123

SUBJECT : Location of the rudder control on the rudder pedals.
Replacement of the rod nut by a guide nut.

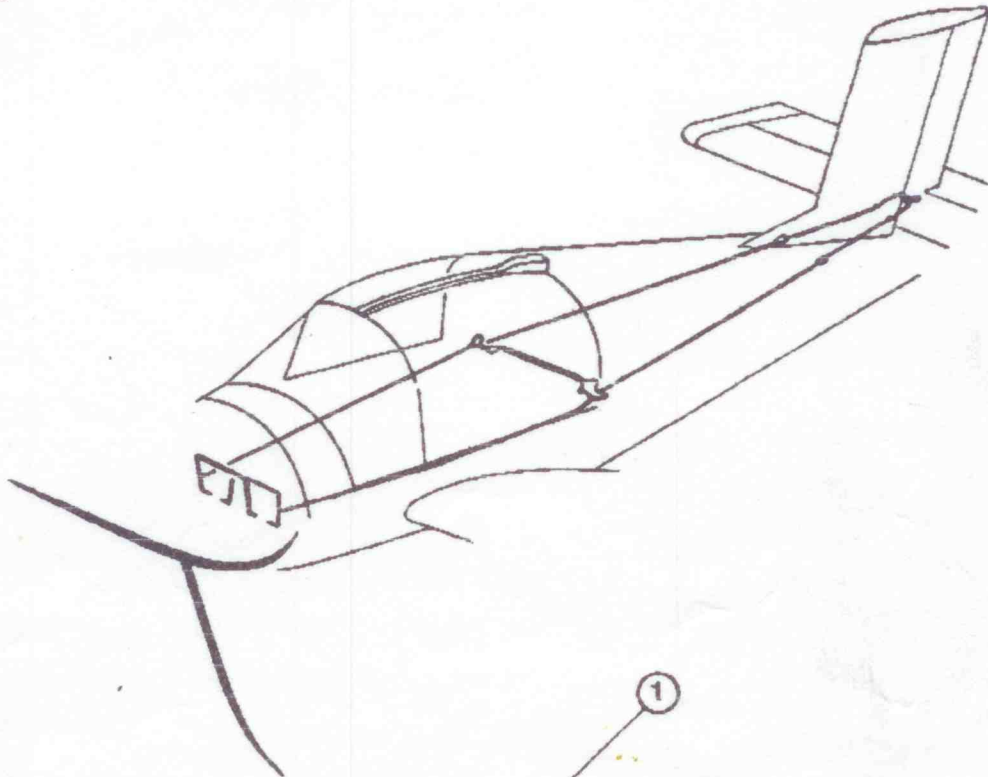
AVANT
(BEFORE)

To avoid any possibility of control rod bending in the place of
its location on the rudder pedals.

On the other hand, at the time of overhaul or maintenance operations, some unusual manoeuvres can create abnormal buckling stresses on the rods (for example : the manoeuvre which would consist in pulling one rudder pedal while the other is maintained unmoved). This buckling may, in borderline cases, cause the failure of the rod in its threaded area, behind the eye bolt which ensures the attachment with the rudder pedal. A few similar incidents having occur, we have provided a safety device which consists in replacing the nut, item 1, by a guide nut, item 2. (see figure on page 2/3). This guide nut which has an important length and is bored at its ends, forms a bushing which is engaged both on the eye bolt tail (previously undercut) and on the plain length of the rod. This prevents any bending in this area.

Although the incidents are caused by anomalies and never occur in normal utilization, we recommend the users to replace the existing nut by the above mentioned guide nut. During this operation, it is obligatory to make sure that the rod is not distorted in its threaded area and that the thread is not damaged. (one of these two anomalies involving to reject the rod). This operation must be followed by a checking of the rudder deflexion.
